MINISTRY OF AGRICULTURE, FOOD AND RURAL AFFAIRS

## Improving Energy Efficiency in Livestock Facilities

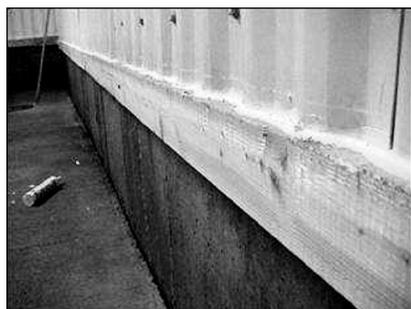
The air leakage around one poorly-fitted standard door is equivalent to a 200 mm (8 in.) diameter hole in the wall. Weather-stripping and caulking are inexpensive and easy to do. The pay back through reduced heat loss is almost immediate. The materials needed to repair one door is less than \$10.00 and the heat saved during cold winter weather could be the equivalent of 1 kW/hr, resulting in a payback period of less than 1 week. [Figure 1](#) illustrates one location where caulking can prevent moisture from entering a wall.

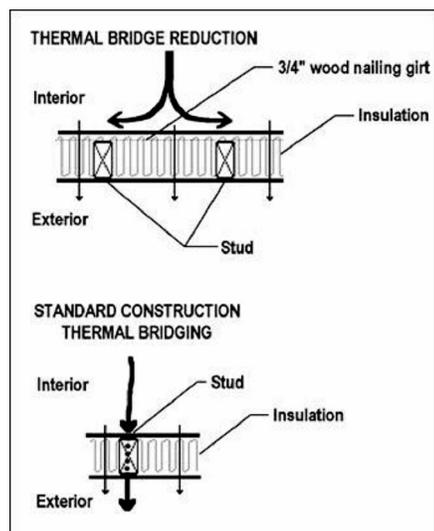
[Figure 2](#) illustrates the thermal bridging that can occur at studs and posts within the wall construction. Thermal bridging occurs in a wall, for example, where a stud or post displaces the insulation. Heat can pass through the wall more easily at those locations, resulting in a significant energy loss. Nailing girts can be attached across the face of the studs to allow the insulation to fill the 'warm side' of the wall. Vertical blocking is a must to prevent rodent runways.

**Figure 2.** Heat flow through a wall is lowered by using a framing technique to reduce thermal bridging.

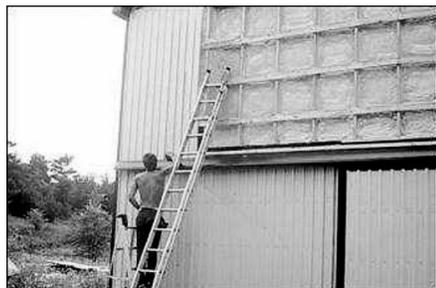
Polyurethane Foam Insulation (PUFI) is another alternative to the more familiar fibreglass batt insulation. Professionally installed and properly protected, it is a durable material with excellent insulation characteristics and is only affected by moisture in conditions where there is a very large vapour drive, as might be found in a cold storage structure. [Figure 3](#) shows how PUFI can be applied to the inside sheathing of the structure before the exterior sheathing is applied.

**Figure 3.** Outside-in technique of insulating a wall using PUFIs. (Photo Credit: Agviro, Inc.)

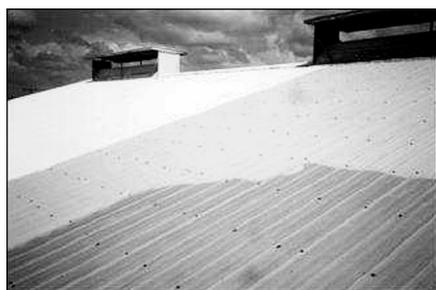
Ceramic coating or paint is a new material that reflects heat. The coating contains millions of microscopic ceramic beads. Like the ceramic tile on the nose cone of the space shuttle, the ceramic paint reflects the infrared rays from the sun while at the same time, reduces heat transmission to the underlying surfaces because the ceramic material is a poor heat conductor. Applied to the interior of the building it acts to reduce heat loss by reflecting the heat back into the room rather than being absorbed into the walls and ceilings. [Figure 4](#) shows a roof that has been painted with a ceramic coating.

**Figure 4.** A demonstration of a ceramic coating applied to a portion of a barn roof. (Photo Credit: Agviro, Inc.)

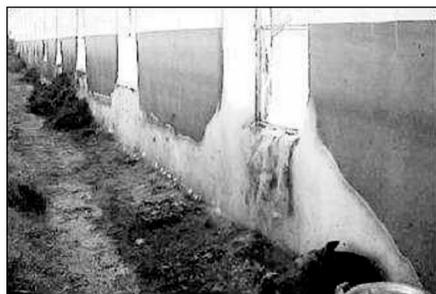
The heat loss from windows is relatively small compared to the ventilation system that accounts for » 80% of the total heat loss. Nevertheless, heat loss from cracks around windows as well as the lower R-value of the glass itself, make windows a questionable investment in livestock facilities. [Figure 5](#) shows an extreme case where windows caused the accumulation of frost and ice. In this case, the ventilation system may be partially at fault. The main beneficiary of natural light from windows is the operator. Animals perform equally well in artificial light. In fact, certain production systems require the regulation of the amount of light provided to animals or poultry in order to improve performance. Natural light from windows could make it more difficult to regulate the required levels of lighting. The amount of energy needed to replace heat lost through windows is much greater than the energy saved in replacing electric lights with natural daylight.
